Advanced
Tribological
Coatings For High
Specific
Strength Alloys,
R&D 5876-MS-01

Contract DAJ A45-
87-C-0044
Final Report

NATIONAL CENTRE OF TRIBOLOGY

NCT Report No 5090/664

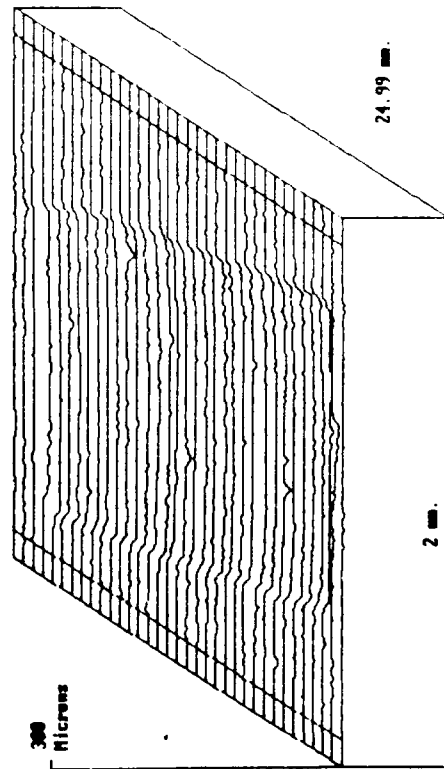
HSSA47 Carbonitrided 4
Wear Volume 0.16 mm³
